# EFFECT OF RESIDUAL ENERGY OF WATER OVER TAIL CHANNEL EROSION

#### P. R. Muke

ME Student , Department of Civil Engineering, Sinhgad College of Engineering, Pune.

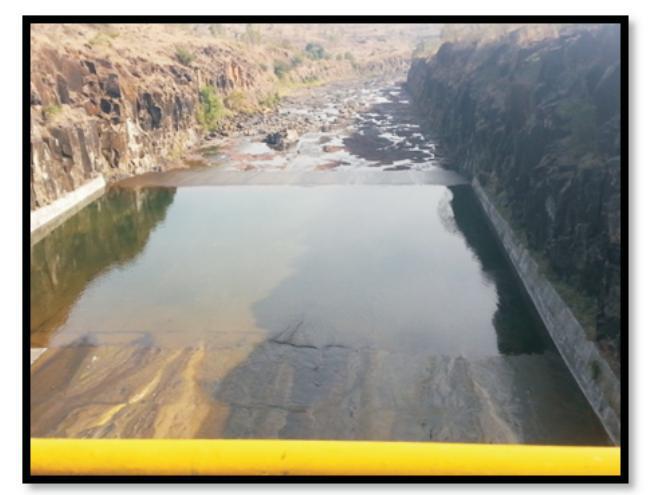
Plate 1: View of tail channel.

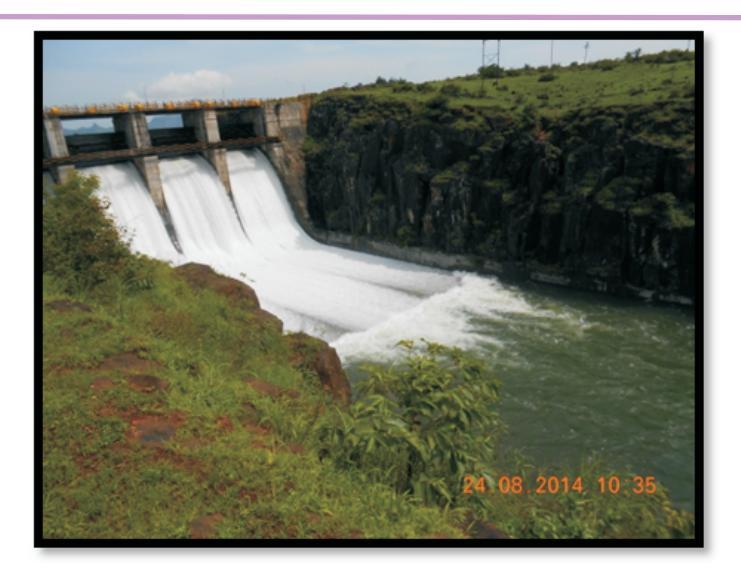
Plate 2: View of spillway when gates were open.

Due to the insufficient tail water depth, hydraulic jump may have tendency to sweep out from the apron portion (Plate 2). For that, location of hydraulic jump plays an important role in case of energy dissipation phenomenon. To avoid the erosion at tail channel, hydraulic jump should be restricted to the apron portion, so that energy dissipation should be maximum. Residual energy which is responsible for erosion of tail channel can be calculated by model study.

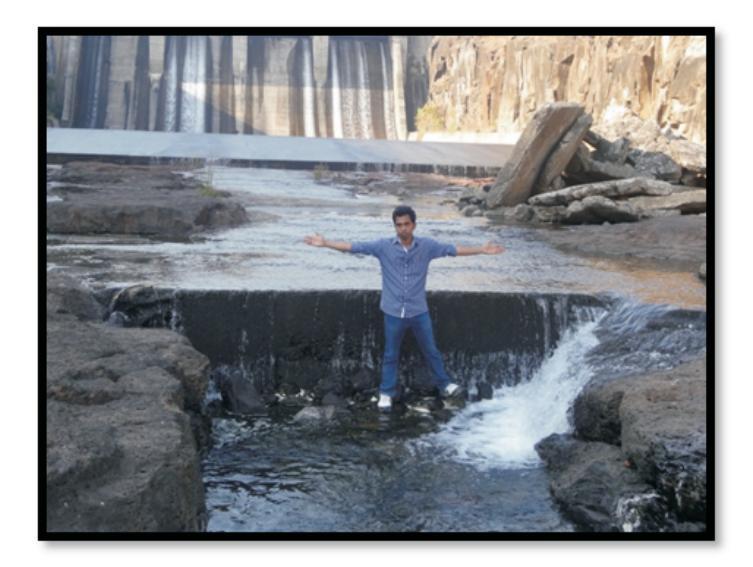
Plate 3: Image shows existence of dyke at tail channel.

The present study area comprises of the three distinctive rocks i.e. Columnar basalt, Red Tachylytic basalt and Zeolitic basalts. The dam is located on the massive basalt, but the spillway has been constructed on the columnar basaltic rock where the red Tachylytic basaltic flow is also observed during the field visit. Structurally the area is sound but the existence of the dyke which runs longitudinal to the spillway channel shows uneven changes in the rock strata. The dyke rock is gabbroic rock and it is exactly to the centre of the spillway (Plate 3). The extension of the dyke from the spillway gate is upto 350 mtrs in the spillway while it extends beyond that from the spillway.

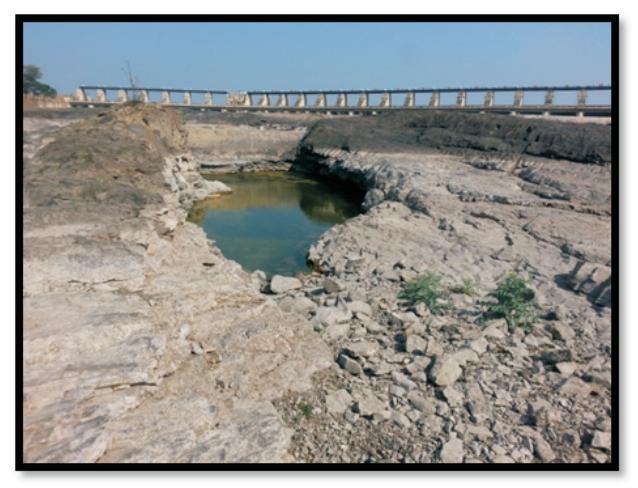
Plate 4: GHOD DAM spillway.

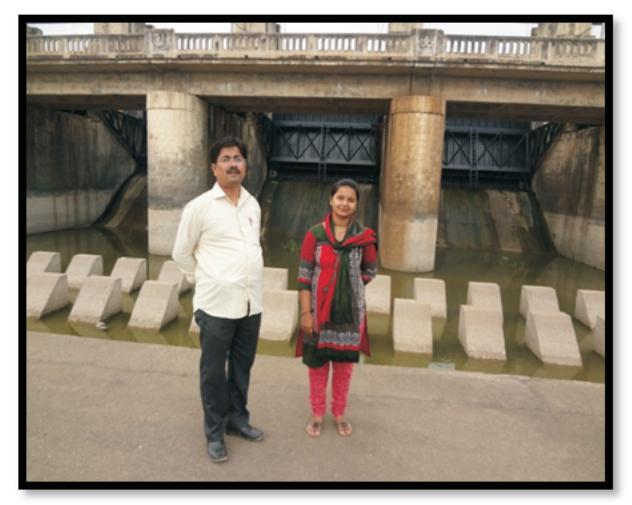
Plate 5: Spillway gates and EDA portion at Ghod dam

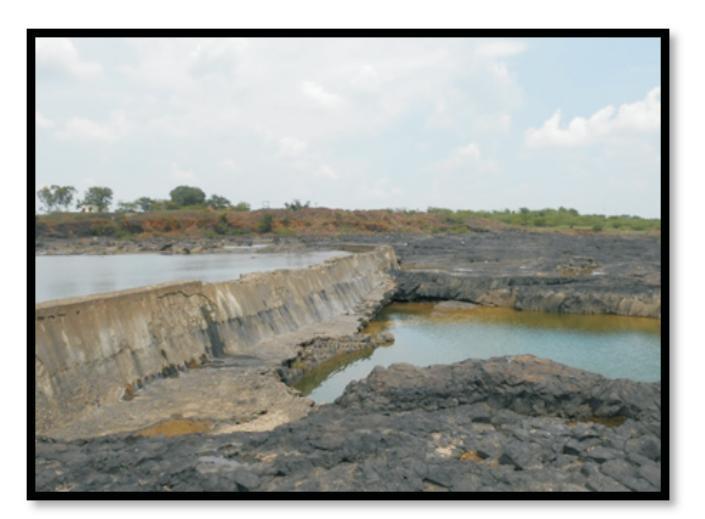
Plate 6: Retaining walls at tail channel

Hard rock exposed in the tail channel is columnar jointed basalt (Plate 7) and volcanic braccia which is soft and altered. A number of retaining walls were constructed to resist erosion but majority of them collapsed (Plate6).

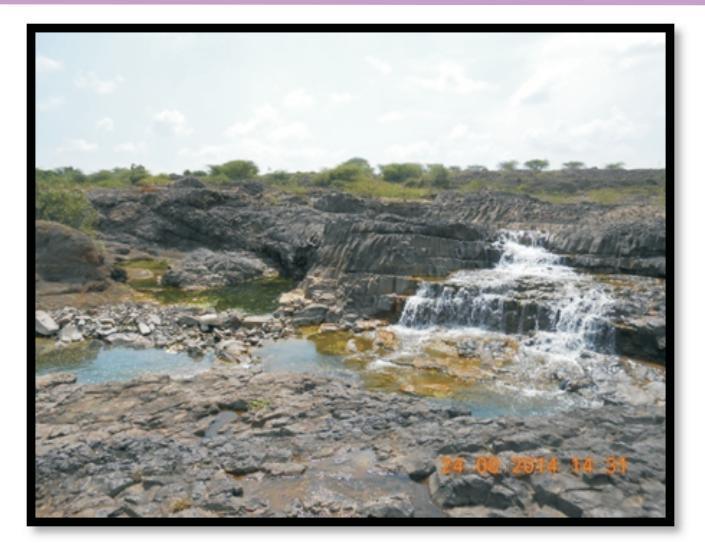
Plate 7: Columnar jointed basalt at tail channel

The natural stream of the river ghod was diverted to the present dam axis. The area comprises with the basaltic terrain where lots of deformations are marked by the tectonic activity. This activity reflects the overturning of the columnar basalt, the orientation of these columnar structured basalts are found to be irregular. Some were they appear to be vertical, inclined and horizontal too. The occurrence of Red Tachylytic and Green Tachylytic basalt is also observed during the site visit of the Ghod dam spillway.

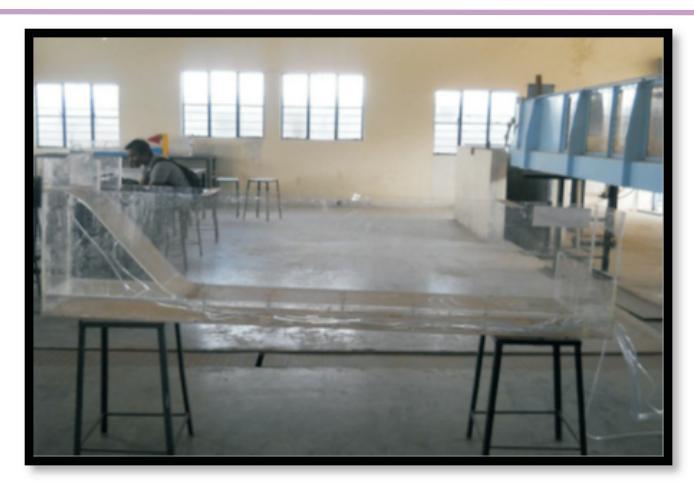
Plate 8: Image of model (BHAMA ASKHED DAM)

Parameter	Prototype	Model	
Height of Spillway (H)	21.2 m	0.424m	
Width of Stilling Basin (B)	55m	1.1 m	
Length of Stilling Basin (L)	75 m	1.5 m	
Design Discharge (Qmax)	1736 m <sup>3</sup> /sec	0.098 m <sup>3</sup> /sec	
20% of Design Discharge (Qmin)	350 m <sup>3</sup> /sec	0.0196 m <sup>3</sup> /sec	
Range of Submergence Ratio (Sr)	0.15 To 0.25	0.15 To 0.25	
Range of Froude Number (Fr)	12.8 To 5.7	12.8 To 5.7	
Design discharge of single bay (Max.)	434 m <sup>3</sup> /sec	0.024 m <sup>3</sup> /sec	
Design discharge of single bay(min)	87.5 m <sup>3</sup> /sec	0.02 m <sup>3</sup> /sec

Scale of model-1:50

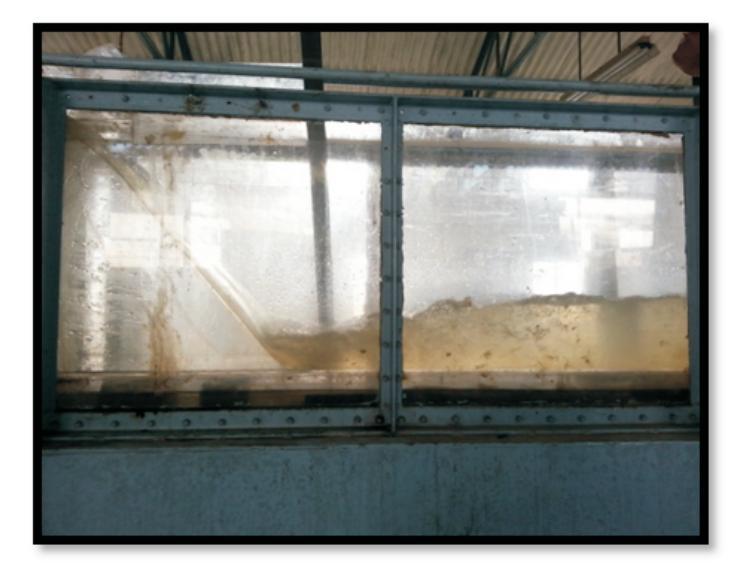
Plate 9: Jump formation in the model

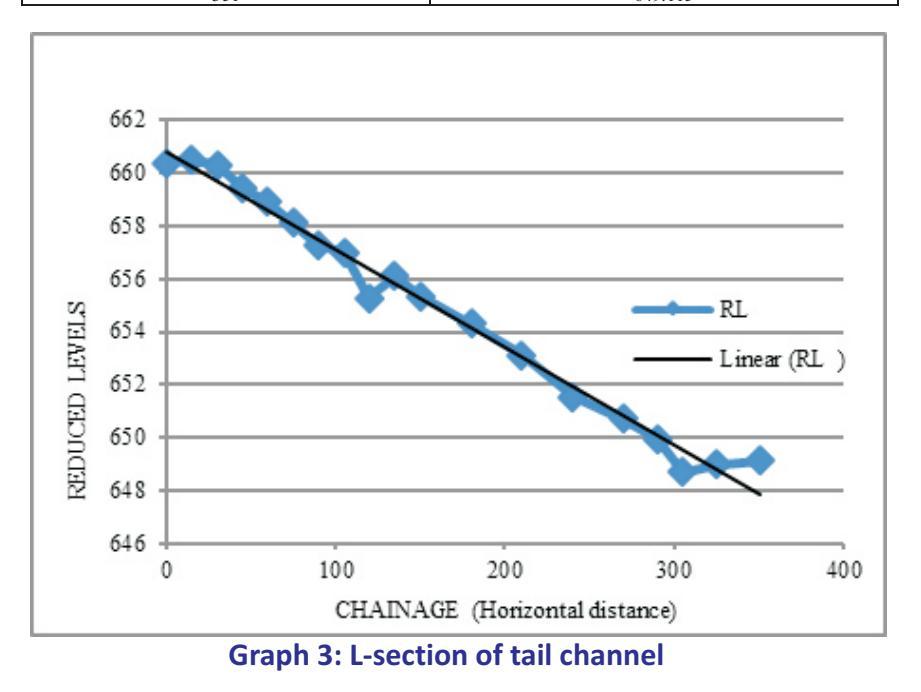
Following table gives elevations (RL) at different points along tail channel of Bhama Askhed dam. From these values of RL, L section is plotted.

Comparison of Old L section and new L section is remaining. Survey at Ghod dam tail channel is very difficult due to rigorous erosion of the channel.

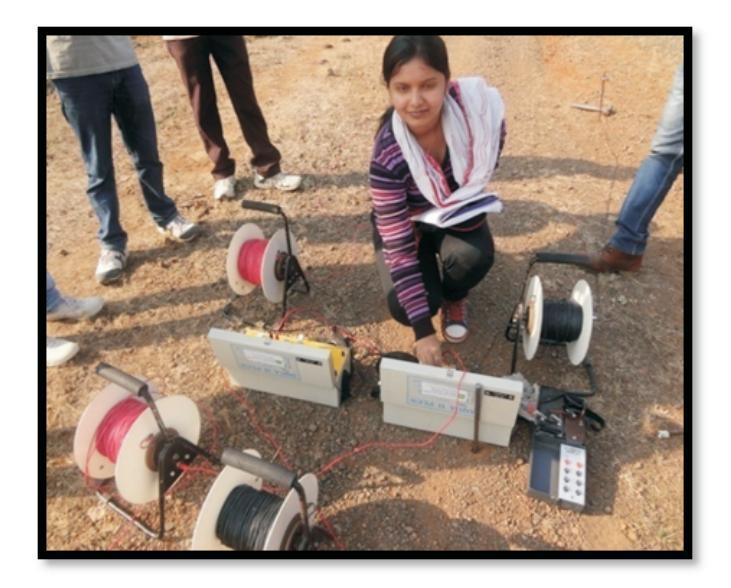
#### Plate 10: ELECTRICAL RESISTIVITY instrument

Electrical resistivity method was difficult to use at tail channel due to the strata at both the sites. Therefore three readings were taken at Bhama Askhed dam along the dam axis and one reading at Ghod dam along its tail channel. Interpretation of this work is remaining. Sample reading is shown in table 4. From these readings graph 4 is plotted which will be helpful for further interpretation work.

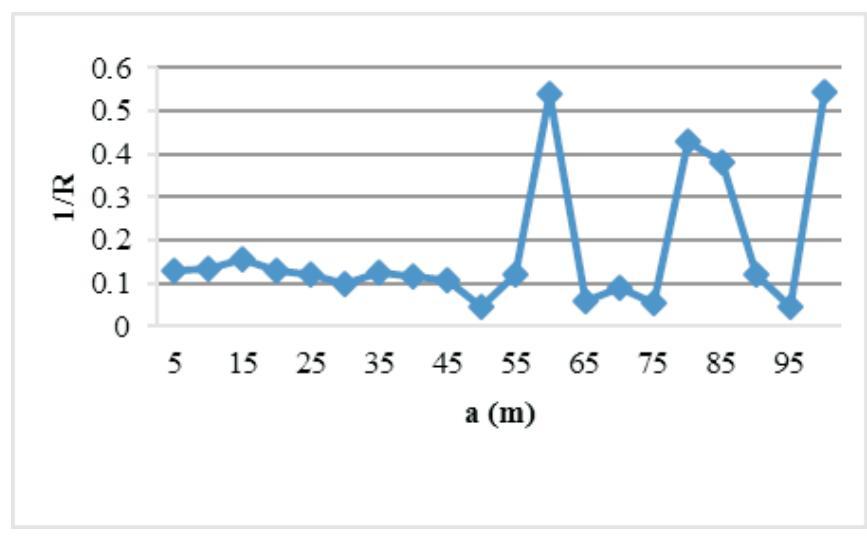
Graph 4: Plot of a versus 1/R
